**SPCC Inspection Photograph Log**

**Little Goose Lock and Dam**

**Inspection and Photograph Date: November 30, 2022**

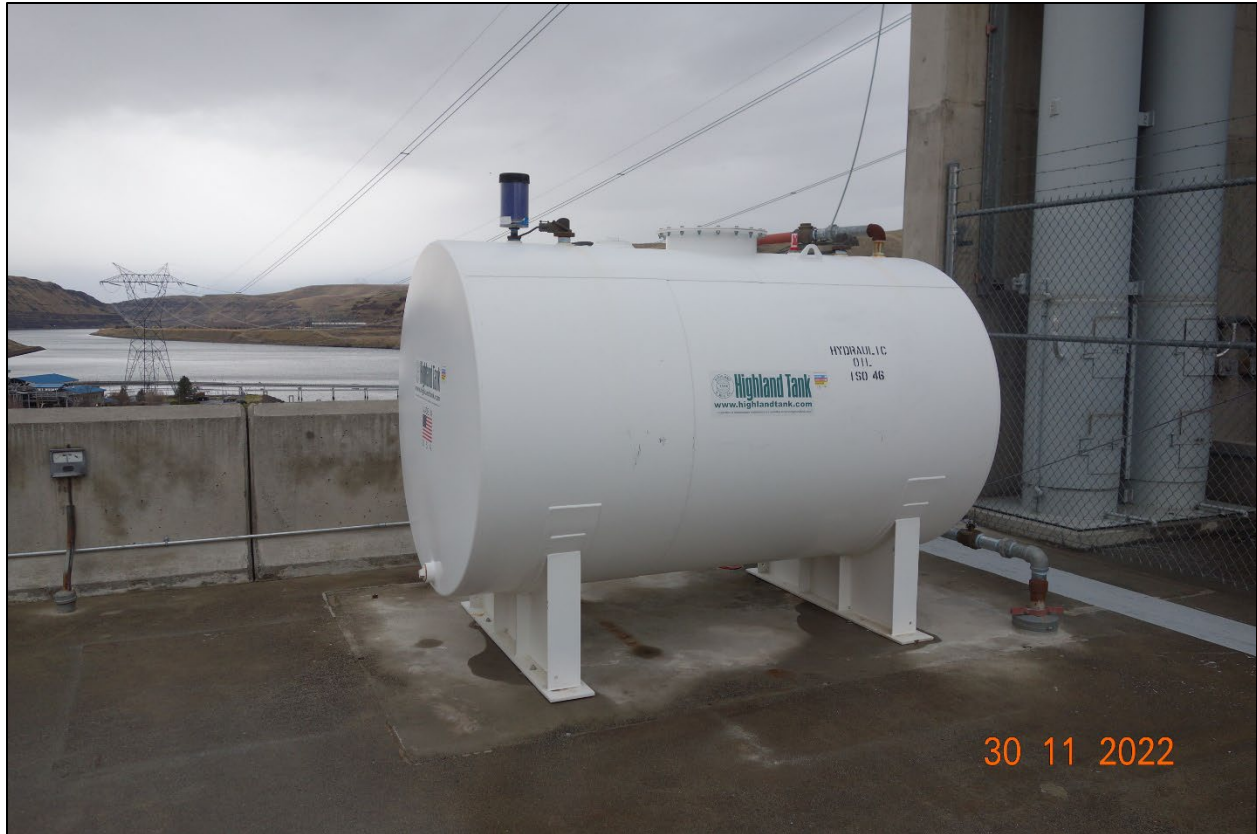
**Photograph 1.** View, facing west, of the double-walled hydraulic oil tank used to control the head gates.

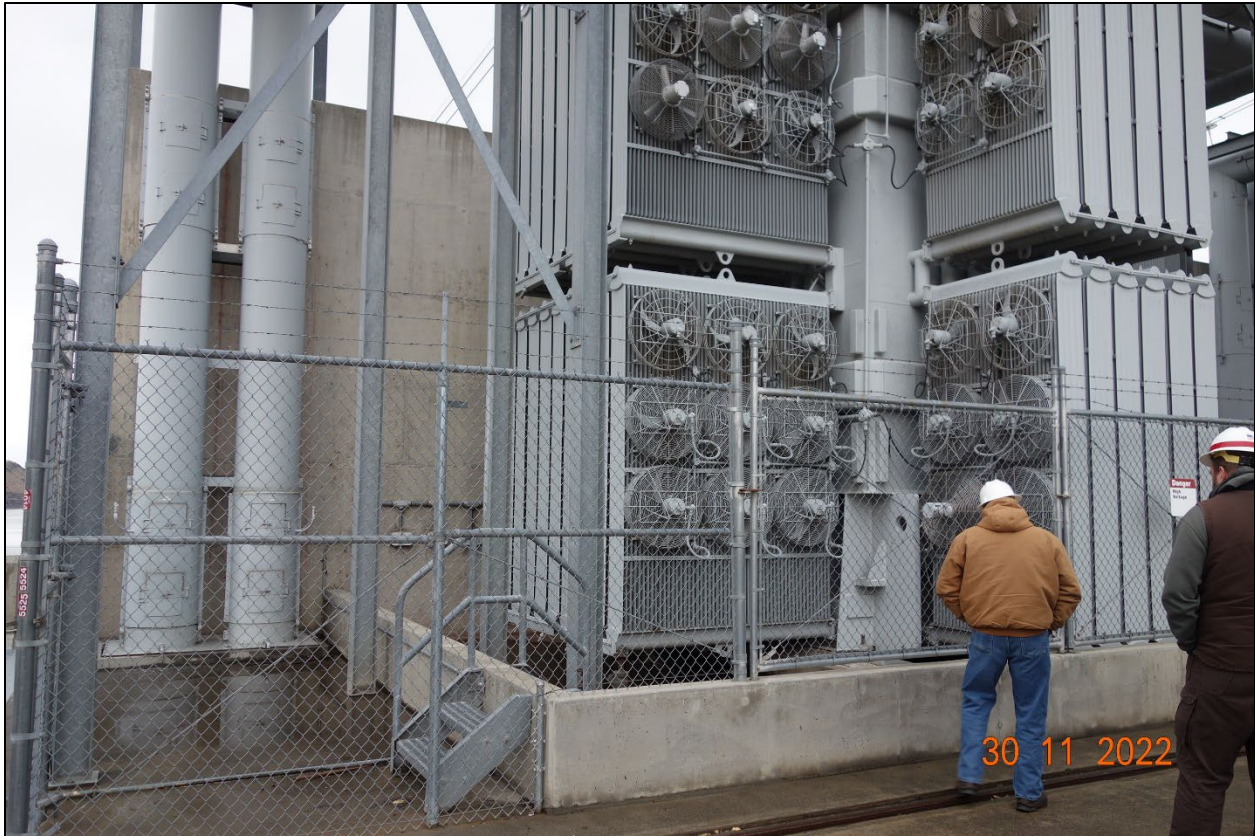
**Photograph 2.** View, facing west, of one of the main transformers located on top of the Dam.

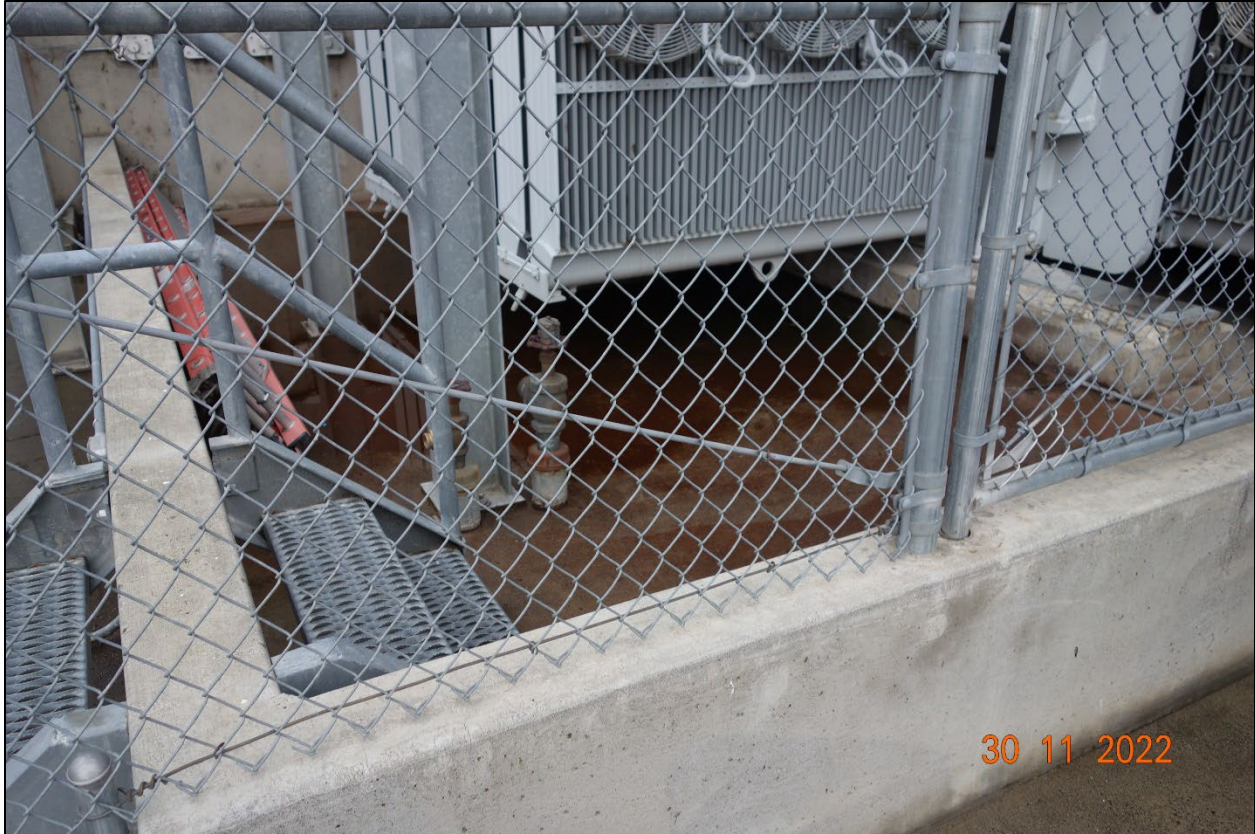
**Photograph 3.** View inside the secondary containment area for the transformer shown in Photograph 2. The transformer secondary containment areas have drains that are plugged. Accumulated stormwater is manually pumped out and passed through a filter before being discharged near the fish screens.

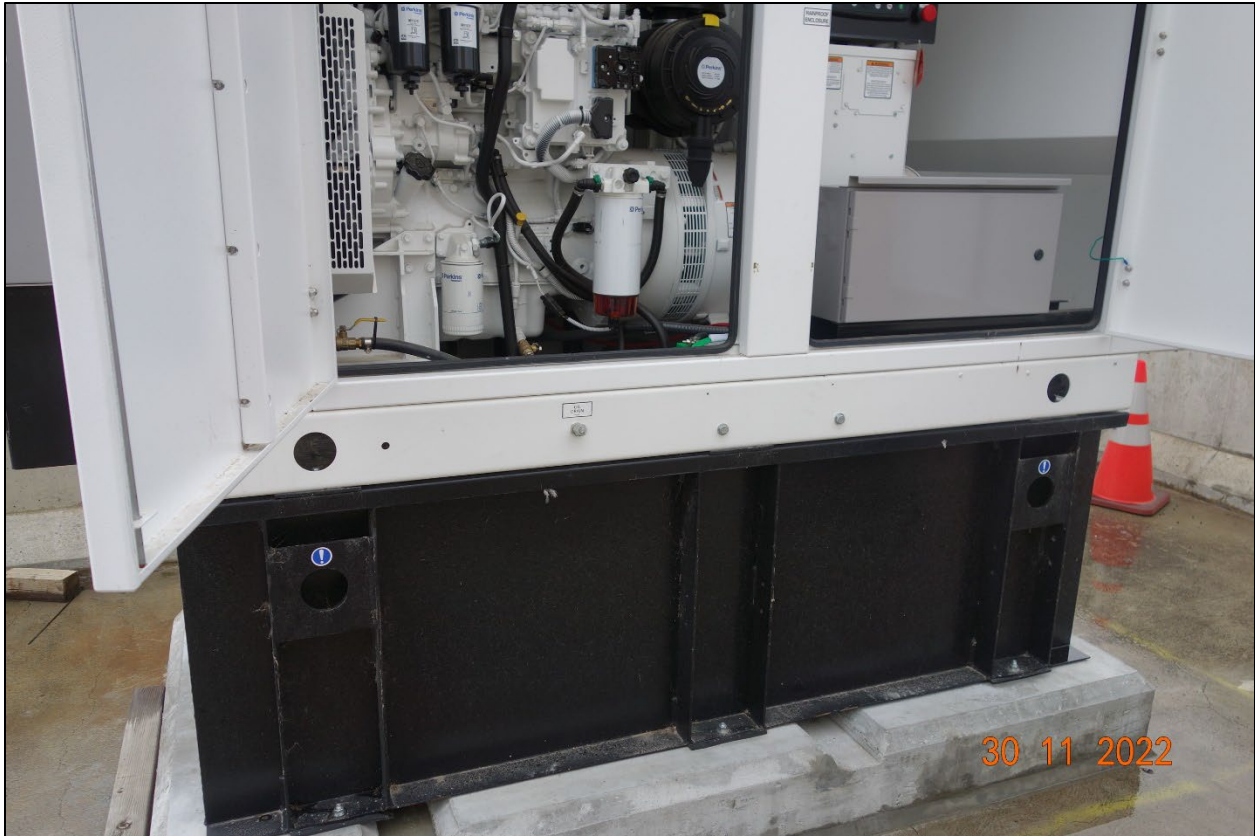
**Photograph 4.** View of a 250-gallon emergency diesel generator with secondary containment built-into the bottom of the unit. At the time of the EPA inspection this generator was not yet in the Facility's SPCC Plan, but it was operational.

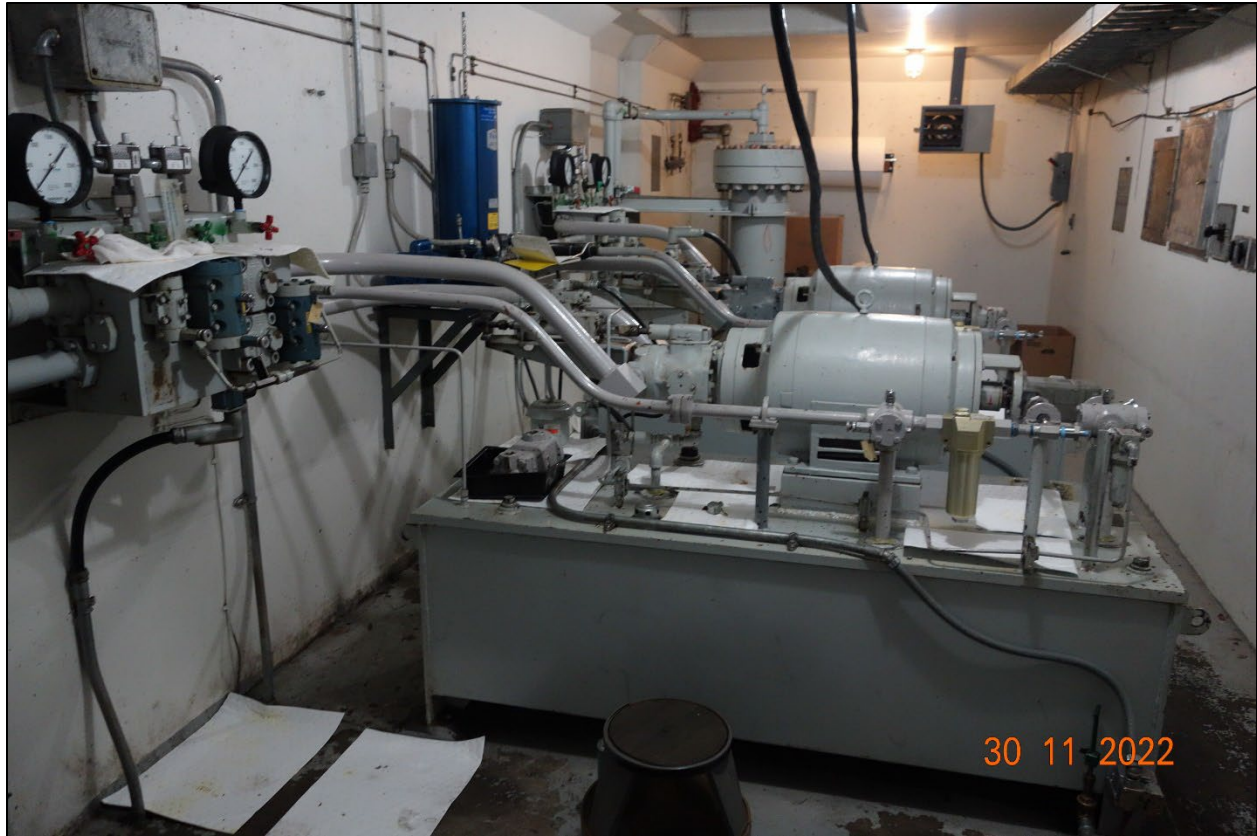
**Photograph 5.** View of the tainter valve room for the navigation lock. The tainter valves are used to drain or fill the navigation lock.

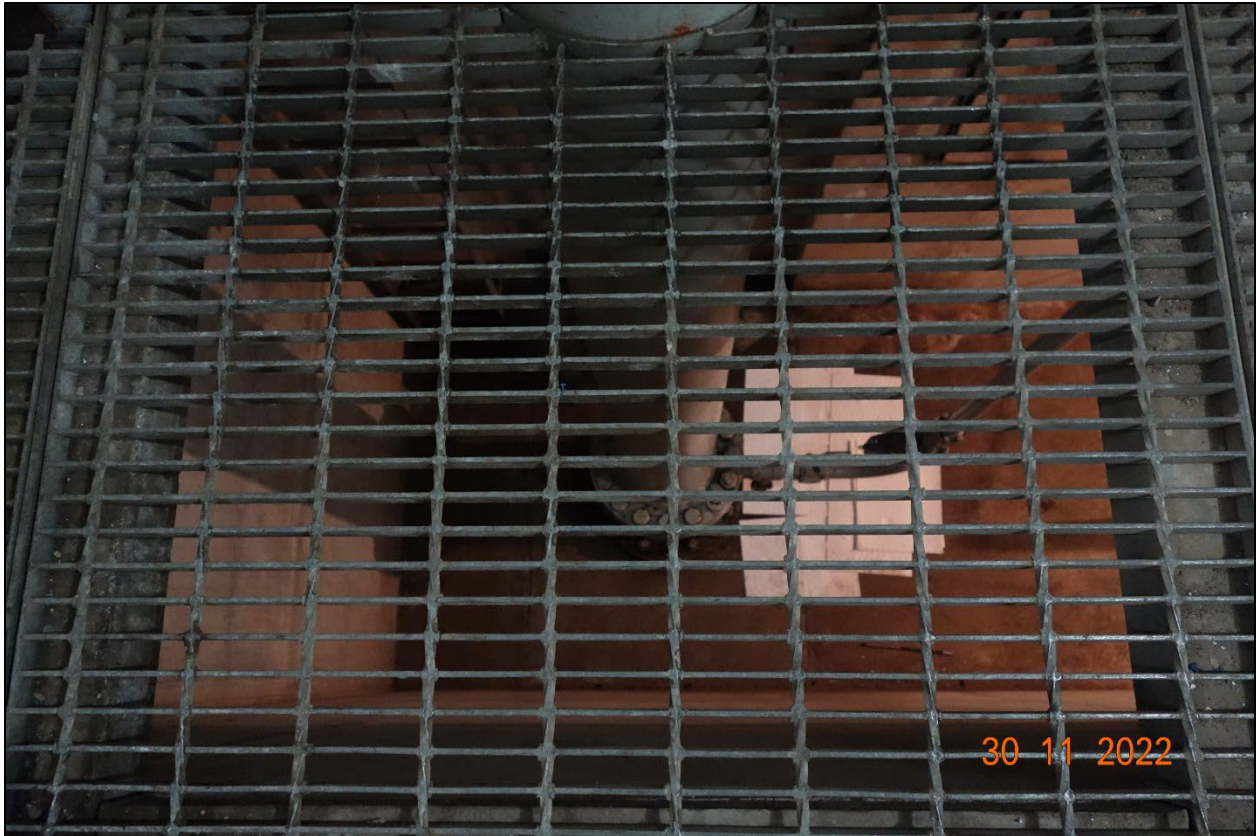
**Photograph 6.** View down into the sump beneath the tainter valve room for the navigation lock shown in Photograph 5. This sump has no drainage connections; any oil or water accumulation in the sump would be pumped out manually.

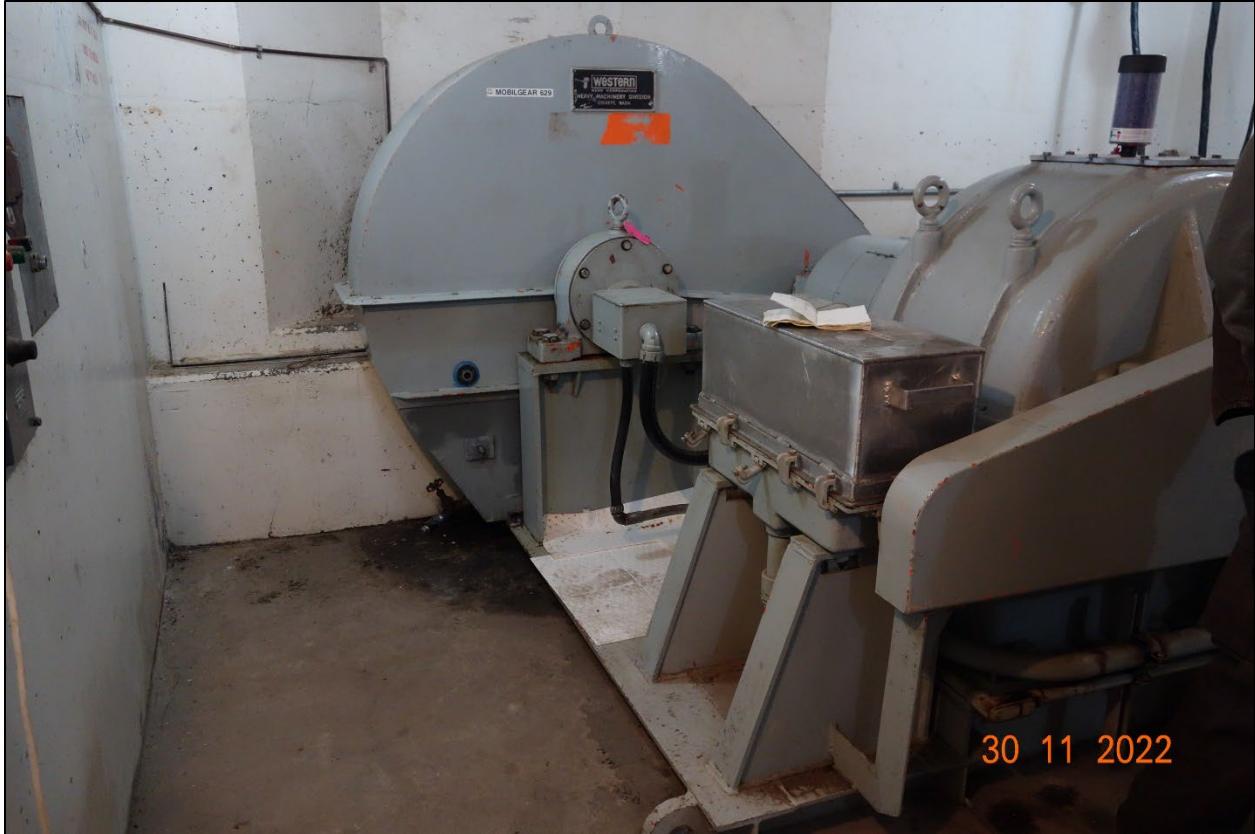
**Photograph 7.** View of the upstream navigation lock gate gear room.

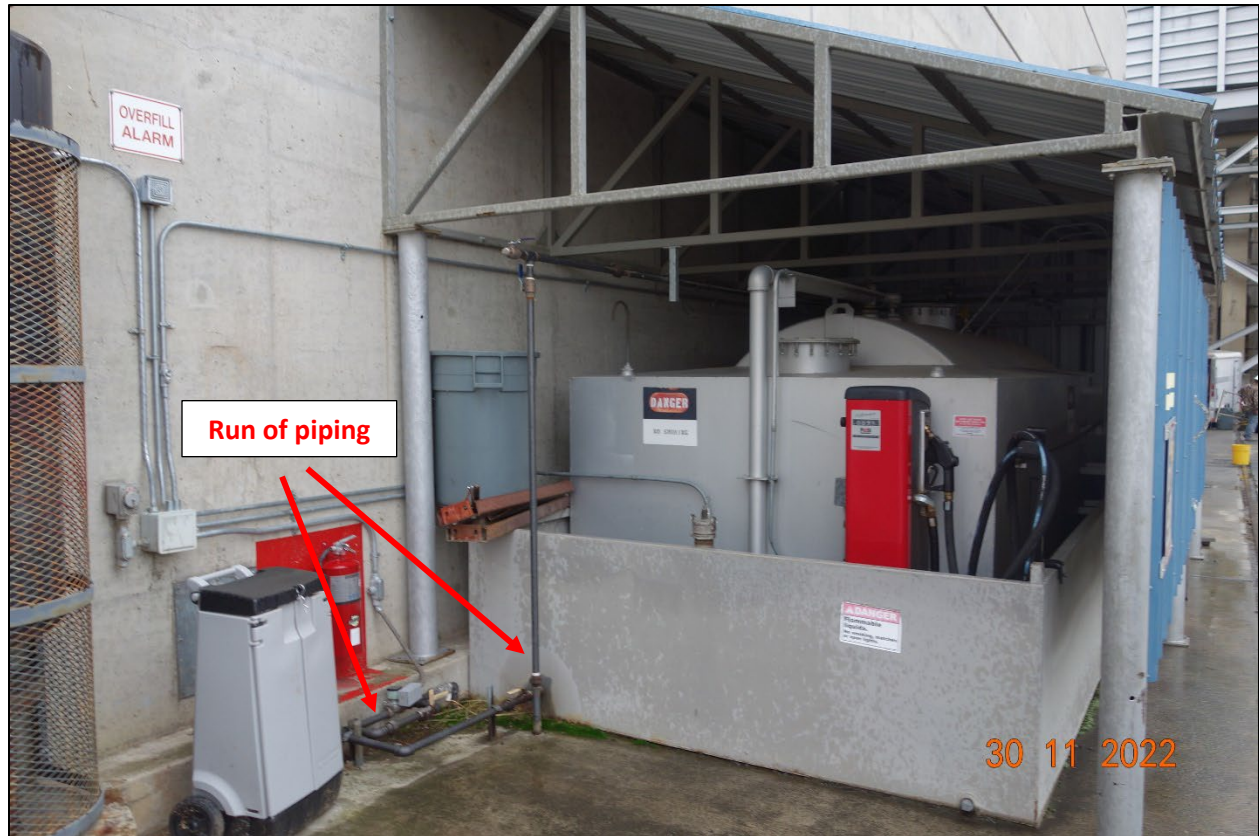
**Photograph 8.** View of a double-walled backup diesel tank within tertiary containment and a small run of piping outside of containment.

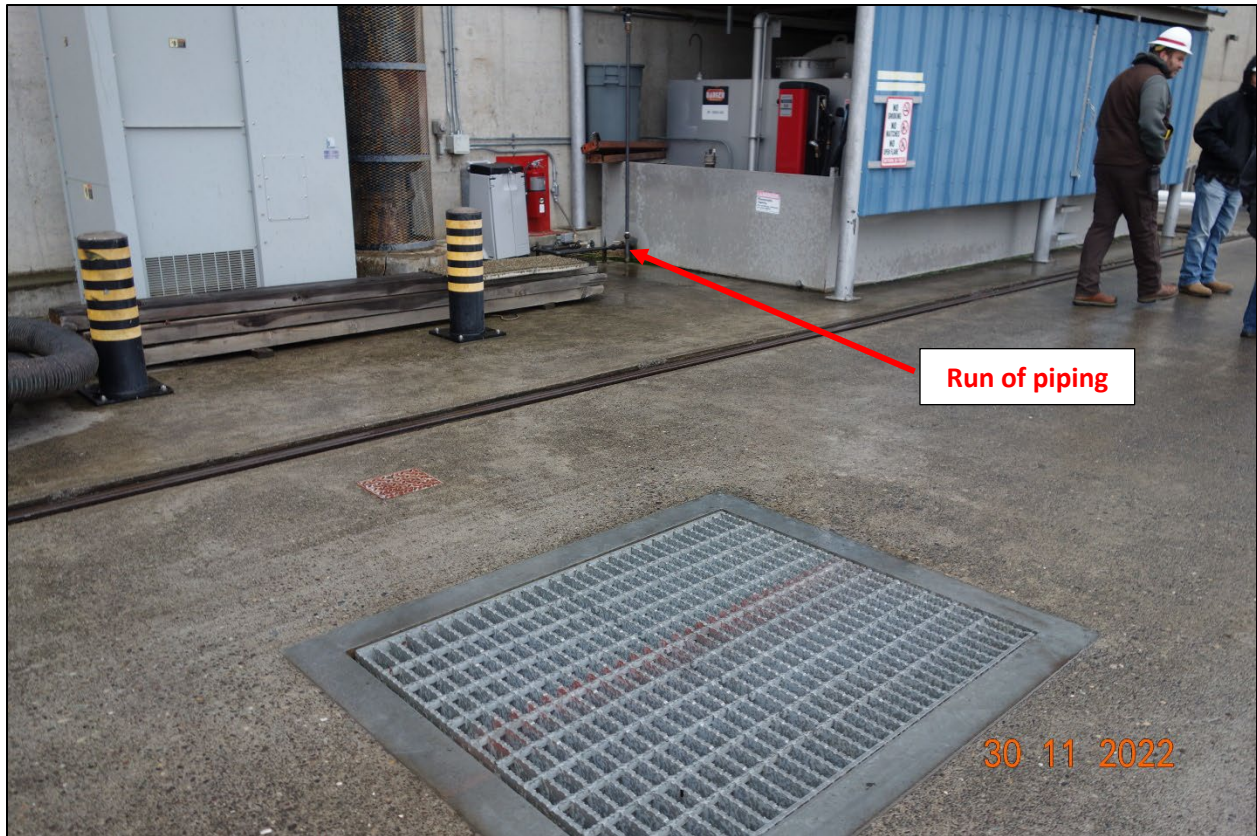
**Photograph 9.** View showing the proximity of the tank and piping from Photograph 8 in relation to a drain that discharges directly to the Snake River.

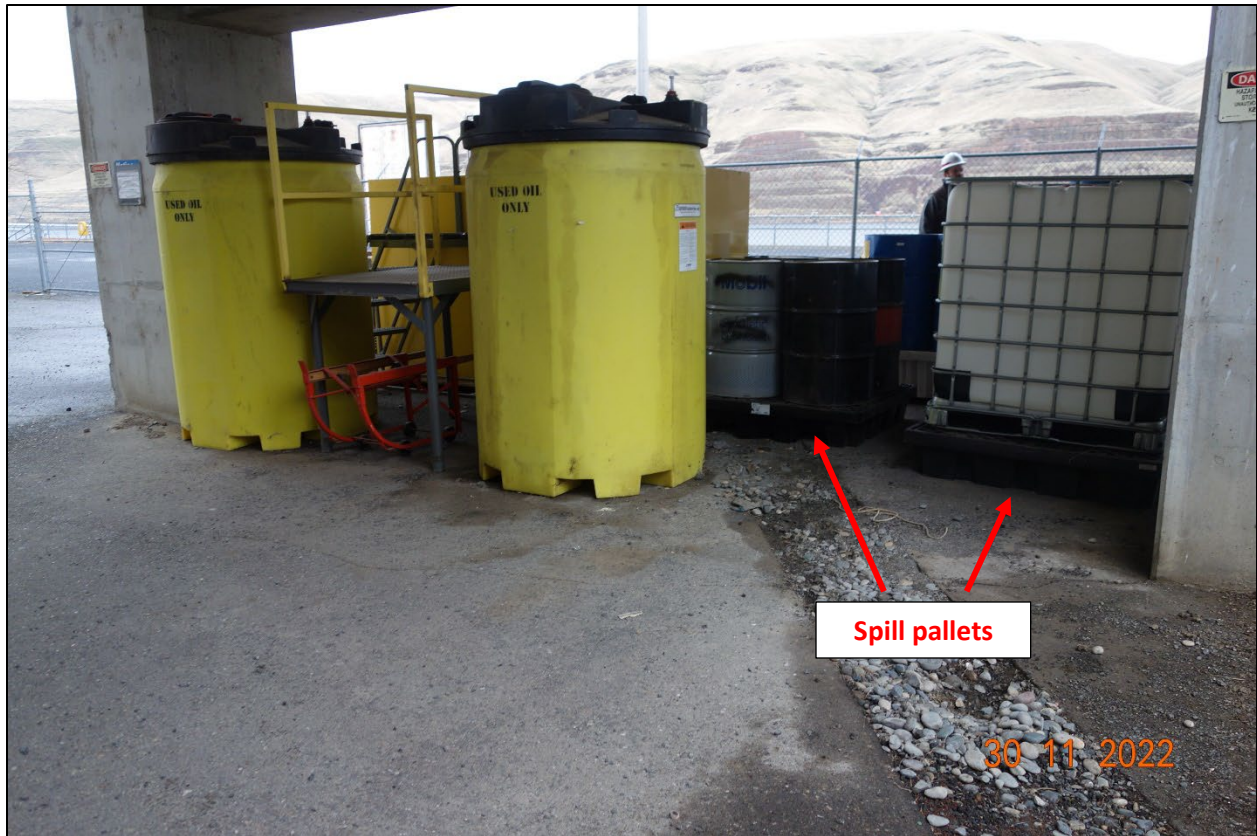
**Photograph 10.** View of the Facility's used oil drum storage area containing drums used during their recent oil spill. All smaller drums and totes are pumped to one of the two yellow tanks, which are double-walled. The drums and totes are located on spill pallets.

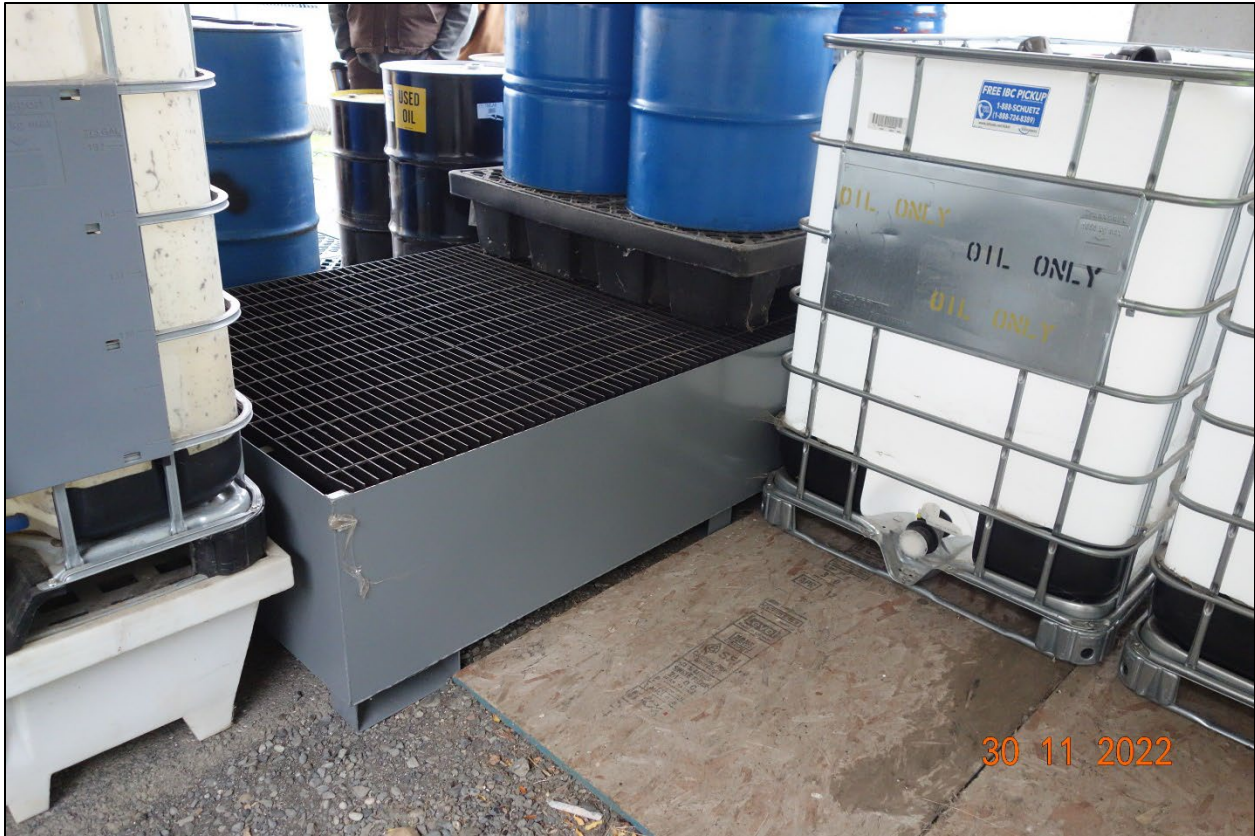
**Photograph 11.** View of the larger spill pallet for totes. All totes shown in this area are either empty or new.

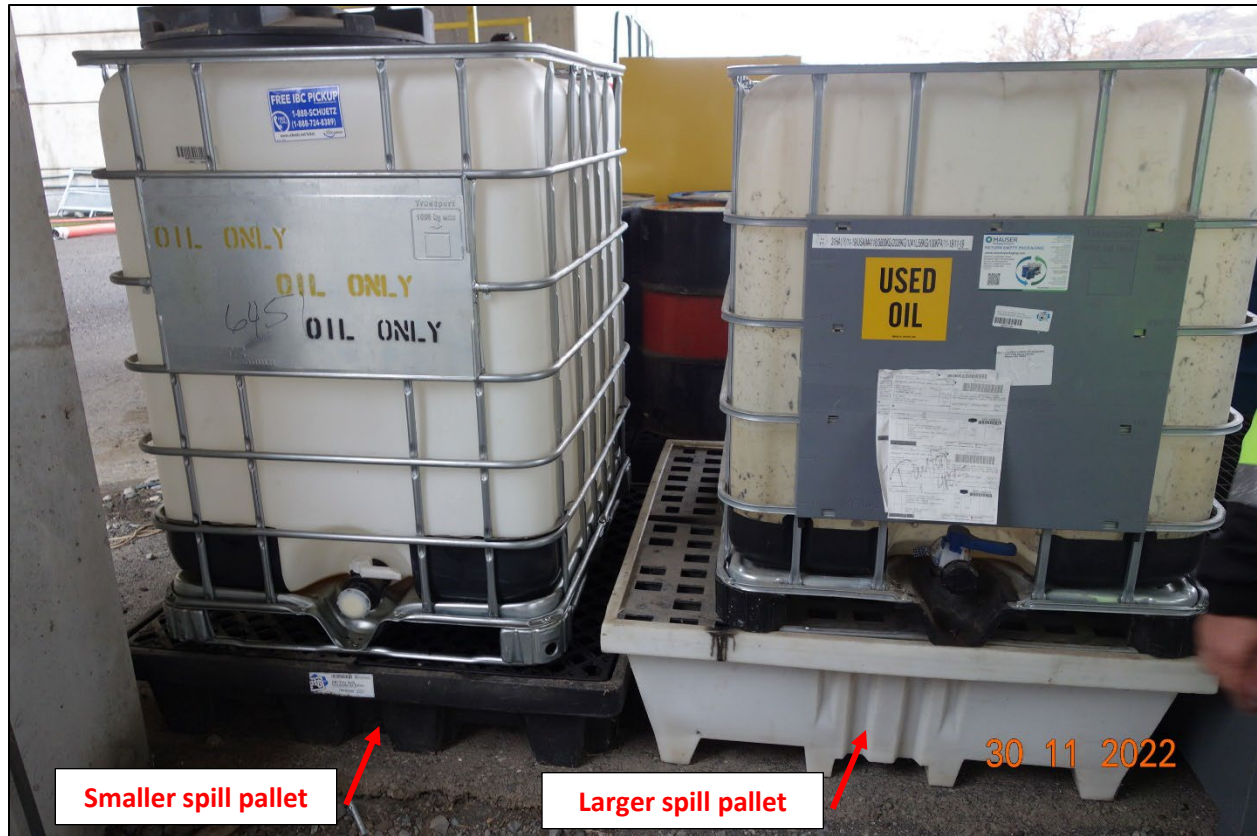
**Photograph 12.** View of two empty but used totes on spill pallets. Note that the spill pallet for the tote on the left is intended for 55-gallon drums, and would not provide sufficient containment for the tote.

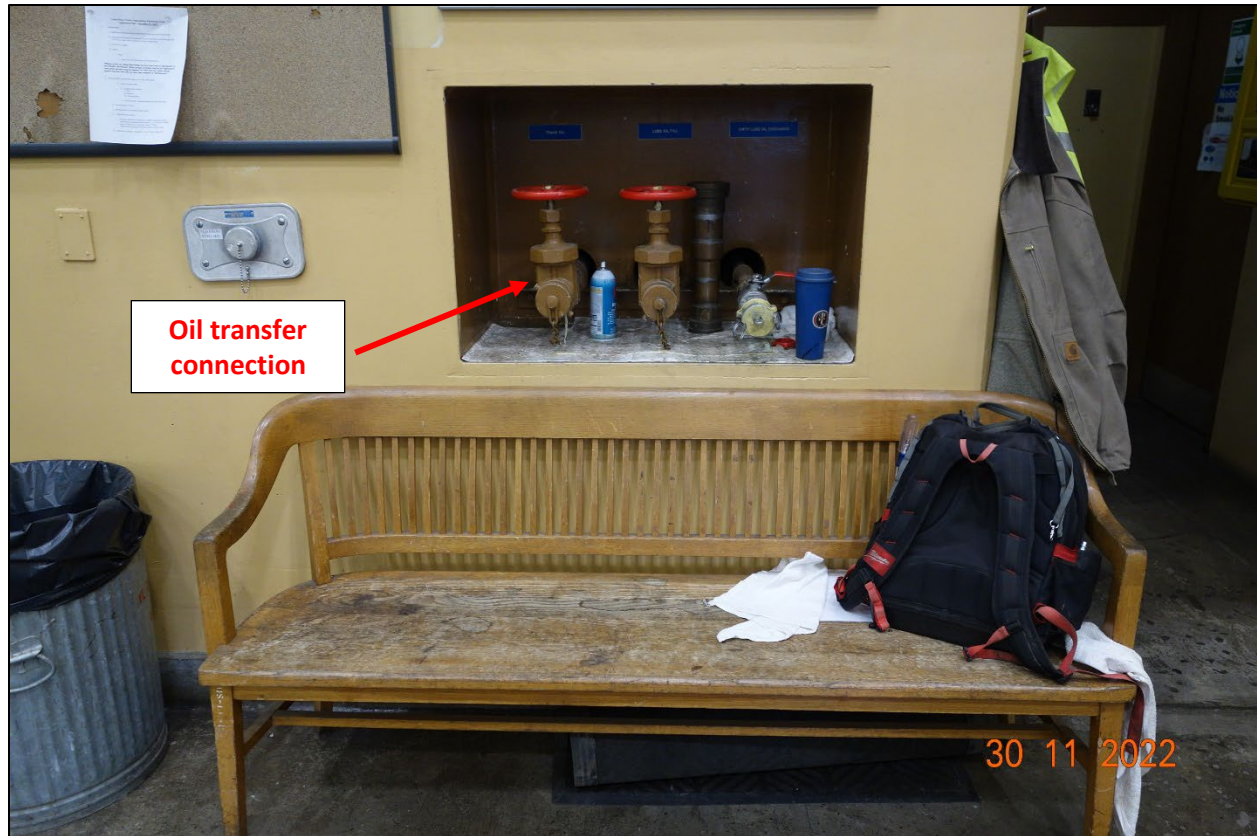
**Photograph 13.** View of the oil loading area inside the turbine hall. Oil trucks are placed in temporary secondary containment when unloading. Additionally, staff are placed at this loading area and at the receiving oil tank during transfers.

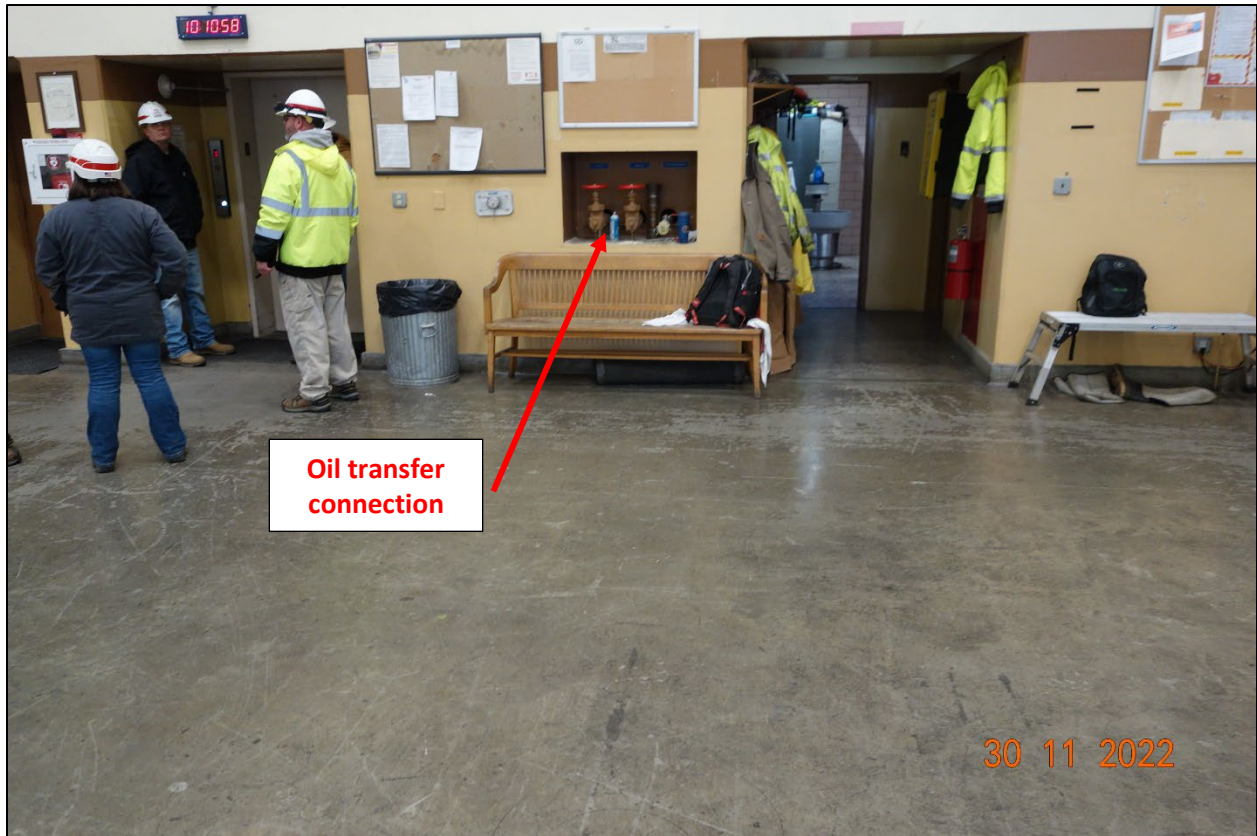
**Photograph 14.** Alternate view of the oil loading area from Photograph 13.

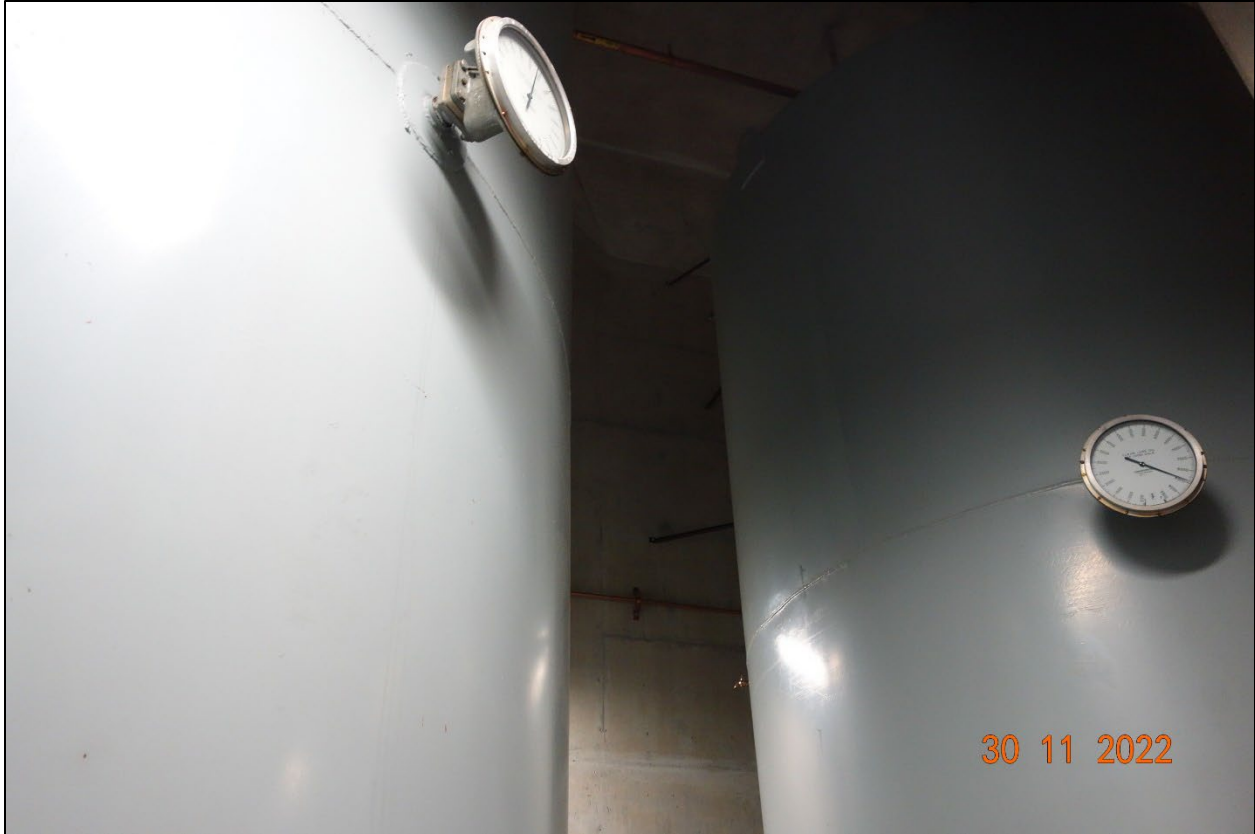
**Photograph 15.** View of two aboveground oil storage tanks located within the clean oil tank room.

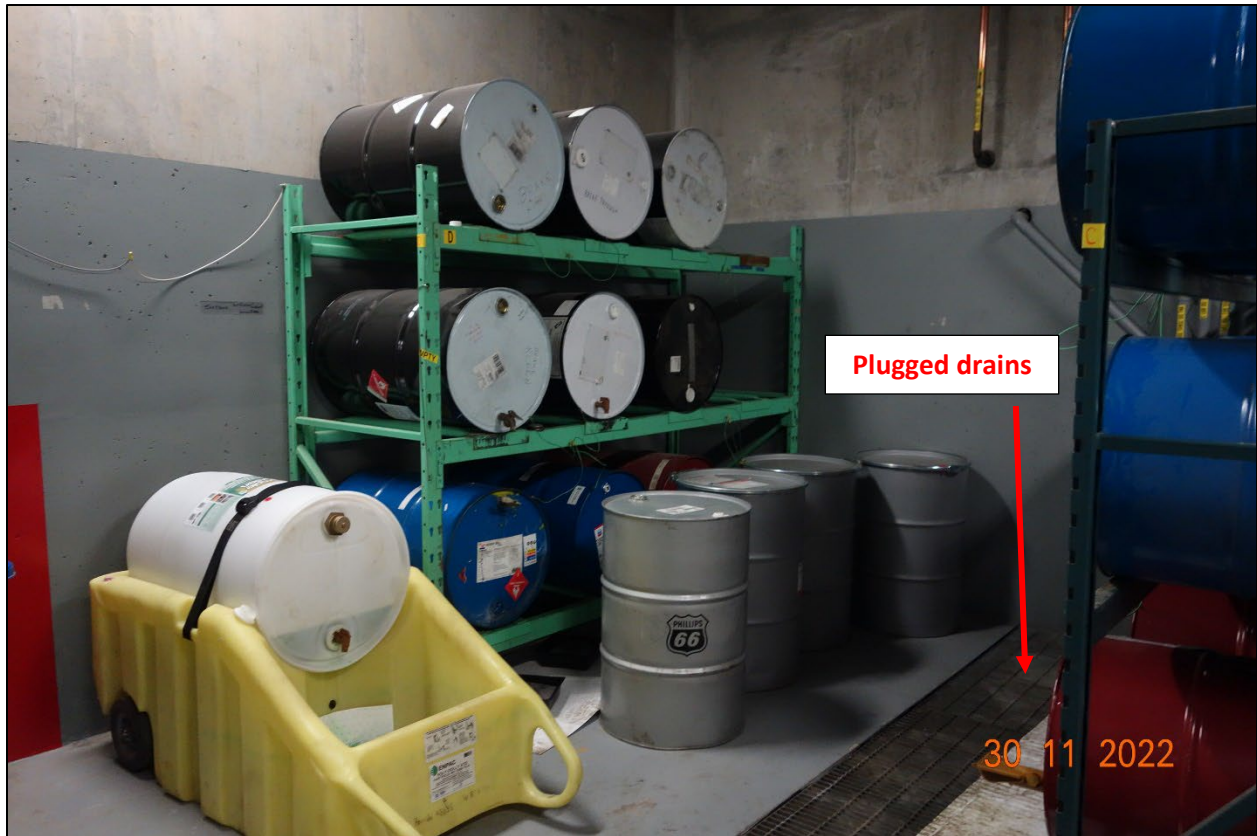
**Photograph 16.** View of drums stored within the clean oil tank room. Note that the drain in this room is plugged; any oil or water accumulation in the room would need to be pumped out manually.

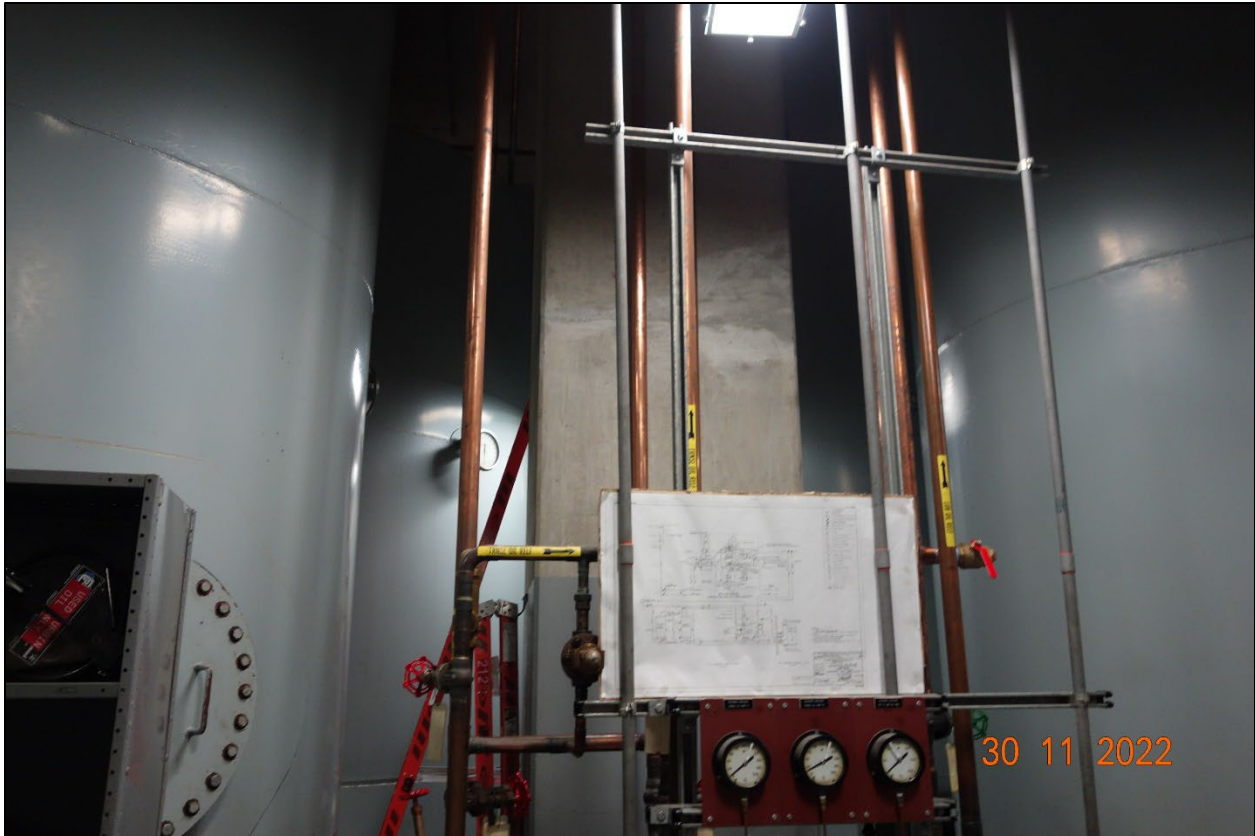
**Photograph 17.** Alternate view of the 4 aboveground oil storage tanks in the clean oil tank room. The concrete room itself provides secondary containment for these tanks.

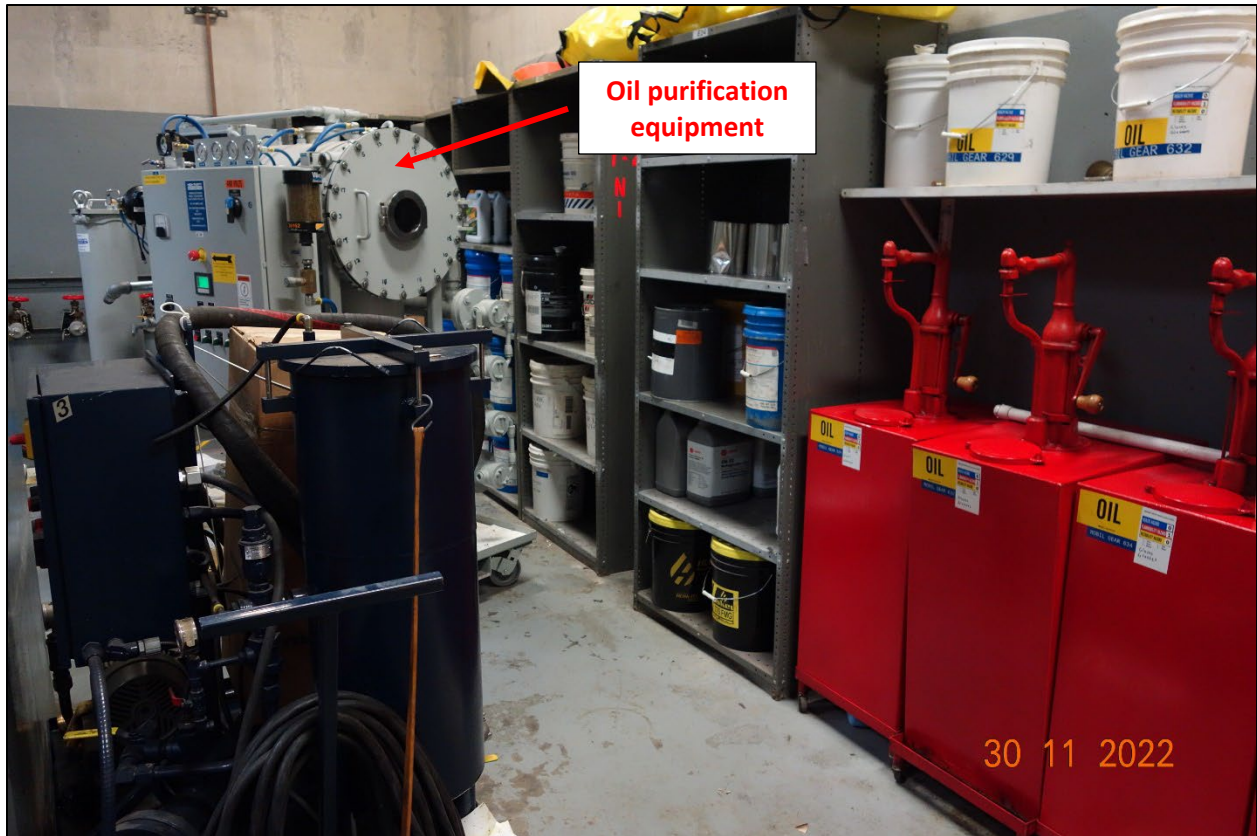
**Photograph 18.** View of the oil purification room with used oil purification equipment. Facility personnel stated that this room is staffed continuously when this equipment is in operation.

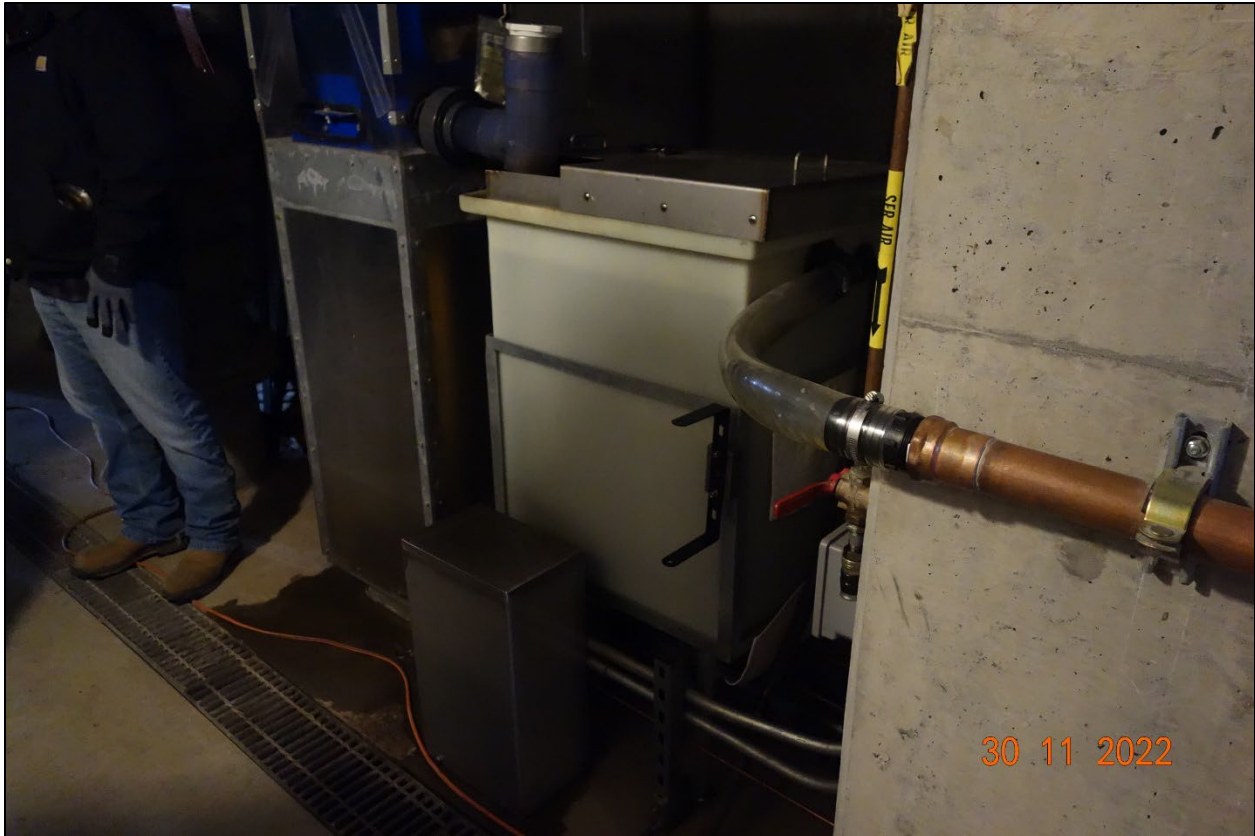
**Photograph 19.** View of the belt oil skimmer for located just before the 140,000-gallon sump in the powerhouse basement. This skimmer has an oil sensor that alerts the control room if oil is detected.

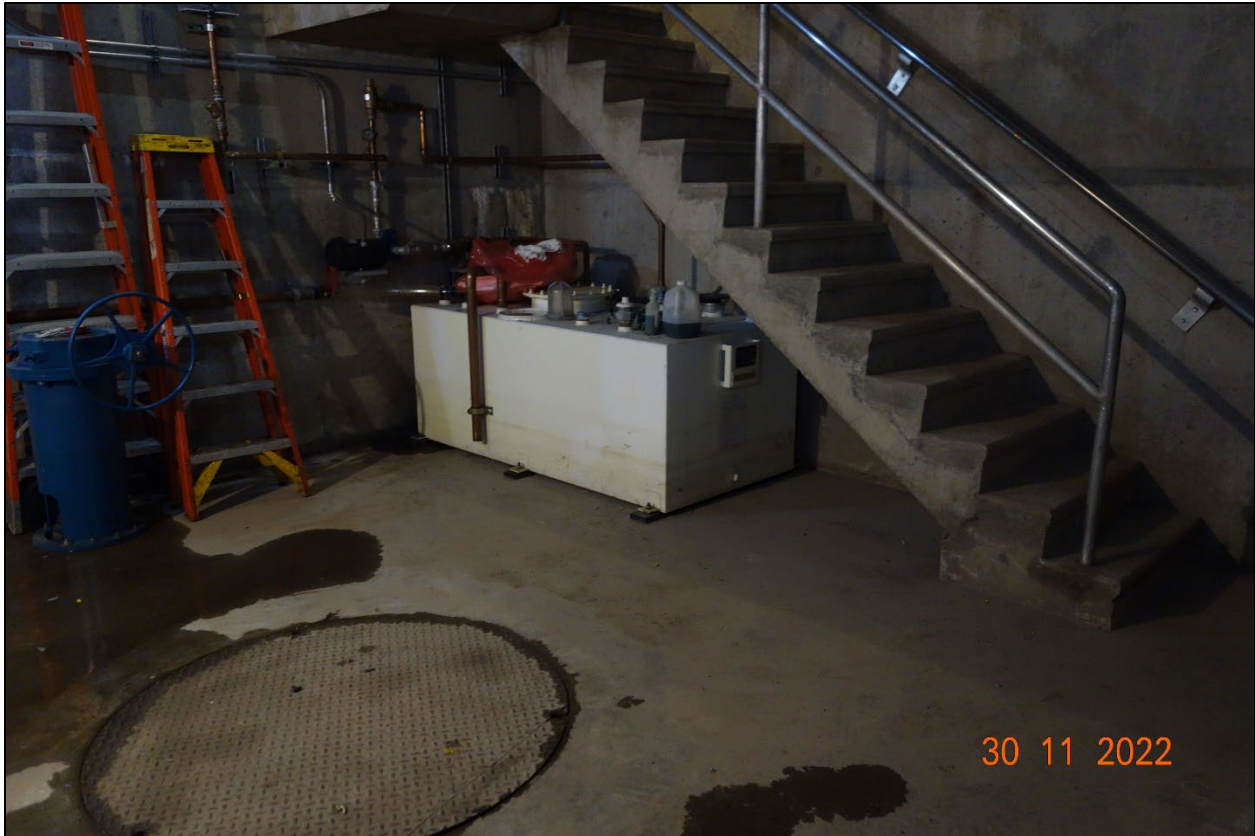
**Photograph 20.** View of a double-walled tank that receives any oil skimmed from the belt oil skimmer shown in Photograph 19. Any oil in this tank is removed from the Facility for disposal.

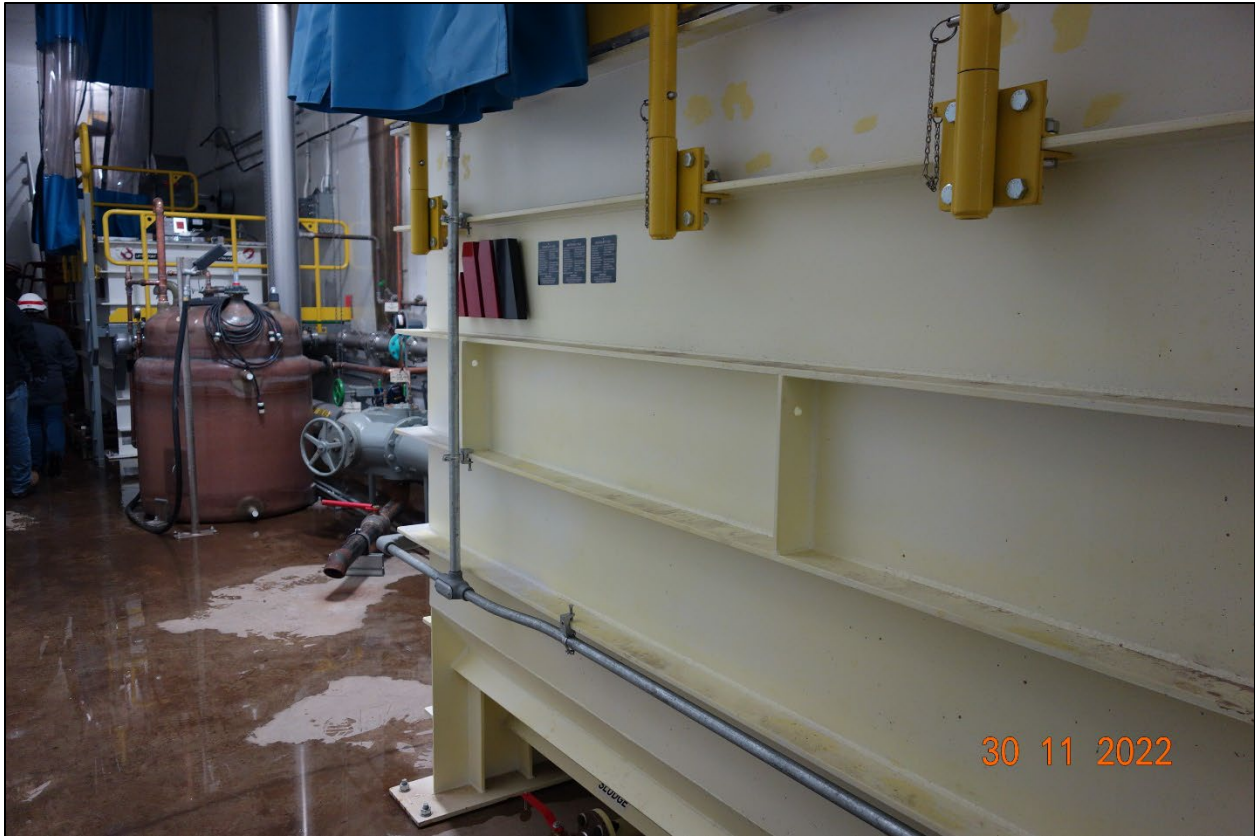
**Photograph 21.** View of the oil/water separator used to separate any oil spills in the turbine pits. This oil/water separator would then discharge to the belt oil skimmer shown in Photograph 19 before discharging to the powerhouse basement sump.
